*Published in:*  
Proceedings of the European Corrosion Congress 2012

# Effect of Ionic Contamination on Corrosion Reliability of Printed Circuit Board Assemblies

*Vadimas Verdingovas, Morten Stendahl Jellesen, and Rajan Ambat*  
*Materials and Surface Engineering, Department of Mechanical Engineering,*  
*Technical University of Denmark, DK-2800 Lyngby, Denmark*  
[vaver@mek.dtu.dk](mailto:vaver@mek.dtu.dk)

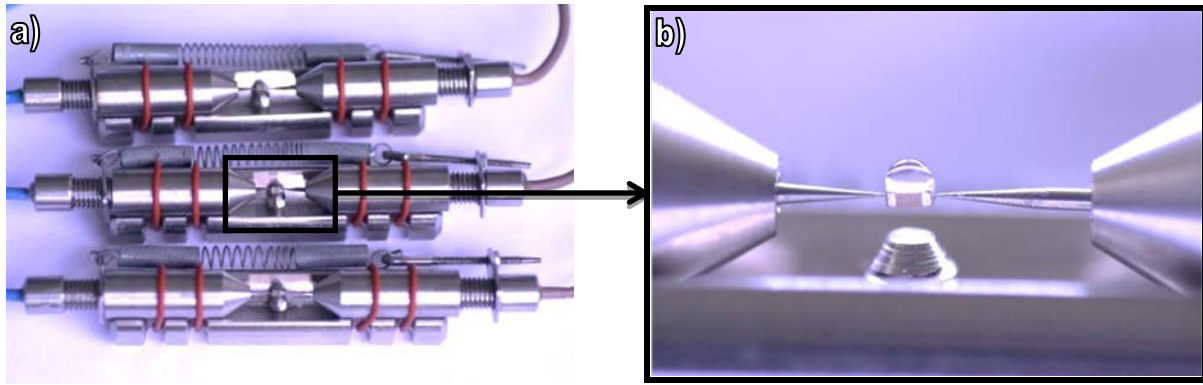
Single component electrochemical migration tests have been conducted using a special setup described by Minzari et al. [10,11]. The single component electrochemical migration (SCECM) setup consists of a sample holder having two small adjustable probes, which act as connectors to each end of the surface mount components (SMC) – in this case ceramic chip capacitors. The entire SCECM setup consists of three separate pairs of metal probes and enables the experiments to be conducted with three chip capacitors at a time, as shown in **Figure 1 (a)**.

**Figure 1:** Single component electrochemical migration setup

The ECM probability testing on the single components was done by placing a micro droplet of electrolyte at a desirable concentration on top of the surface mount components. The current was measured between the terminals of the components which are bridged via the droplet of electrolyte solution and biased at DC voltage in the range of 1 V – 25 V using an in-house built multi-channel multiplexer unit called “CELCORR test PCB set up”, described elsewhere [12]. The leak current followed by the current increase due to ECM (electric short due to dendrite formation) was measured with a 1  $\mu$ A resolution ammeter connected in the circuit via a two switch system. The sampling rate for the leakage current reading was set to 1 s. The experiments were carried out under ambient conditions: temperature 23.5°C – 24.5°C, relative humidity 30% – 40%.

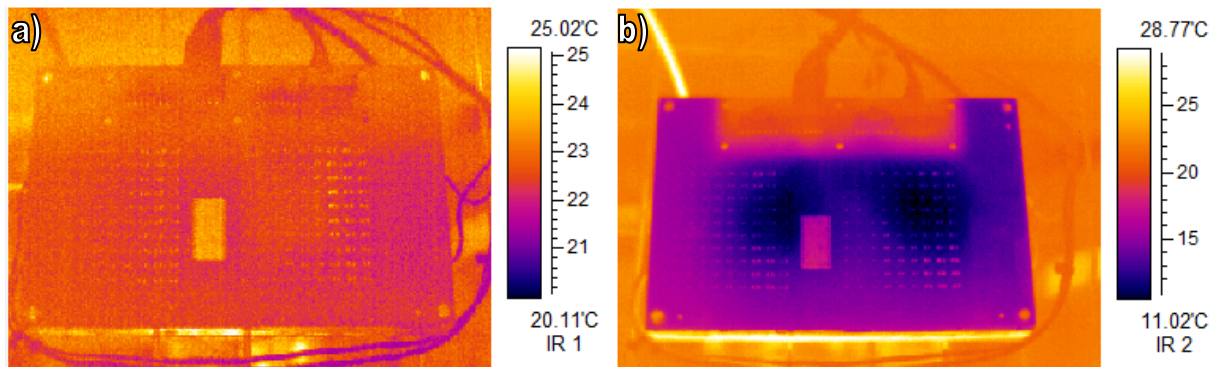
The temperature of the PCB was controlled by mounting the PCB on an aluminum block with embedded Peltier elements. The heat from the hot side of the Peltier elements was removed using a coolant passing through the hollow aluminum block. A DC power source (EA-PSI 6032-06 32V/6A) was used for applying potential to the Peltier elements. The surface temperature of the PCB mounted on the aluminum block was measured with two platinum Resistance Temperature Detectors (PT1000 class A) connected in a 2-wire circuit. DaqLink data logger “Fourier Systems DBSA720” was used to log the temperature/voltage readings on the surface of PCB throughout the duration of the experiment. The cooling effect on PCBs placed on the aluminum block is presented in **Figure 2**.

**Figure 2:** Temperature profiles of test PCB fixed on aluminum block with embedded Peltier elements taken at ambient temperature of 25°C: (a) – without cooling; (b) – 4V DC is applied on Peltier elements

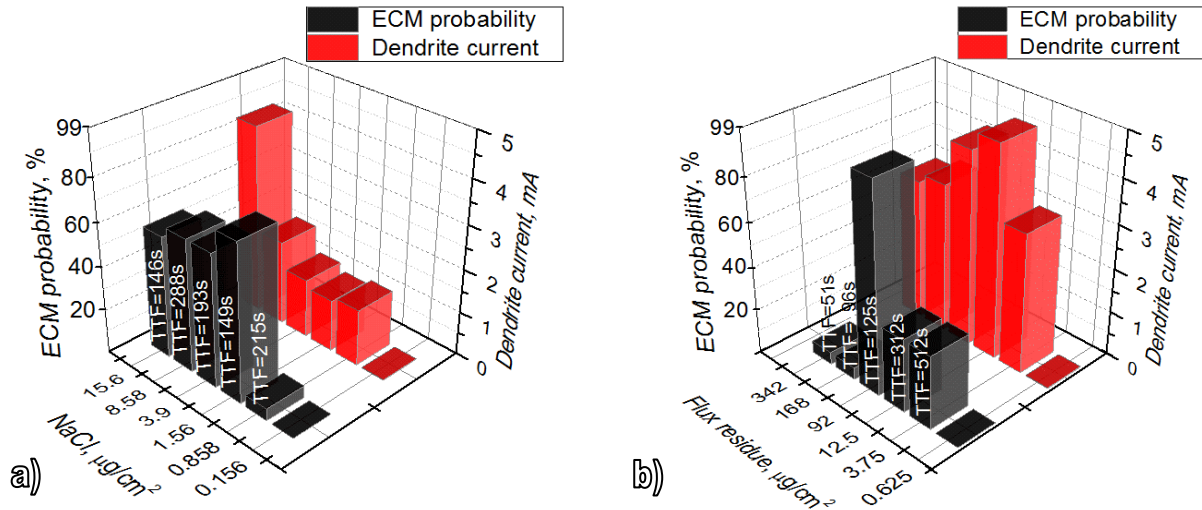
**Figure 3** shows the probability of migration (number of capacitors which showed ECM out of 18 experiments in each category expressed as a percentage) and the average dendrite current for NaCl and flux residue as a function of concentration. The average time to dendrite growth initiation marked as time to failure (TTF) corresponding to each set of experiments is shown on the bar.

**Figure 3:** ECM probability and dendrite current as a function of concentration: (a) NaCl and (b) flux residue

Further increase in flux residue concentrations caused only a low probability of migration (**Figure 3 (b)**), while the component shown in **Figure 5** shows heavy corrosion of the anode terminal, but no dendrites or precipitation of tin hydroxides as was seen in the case of NaCl. This appearance might indicate that the pH level of solution was moved towards the acidic area due to the high levels of weak organic acids in the flux residue and therefore the precipitation of tin hydroxides was

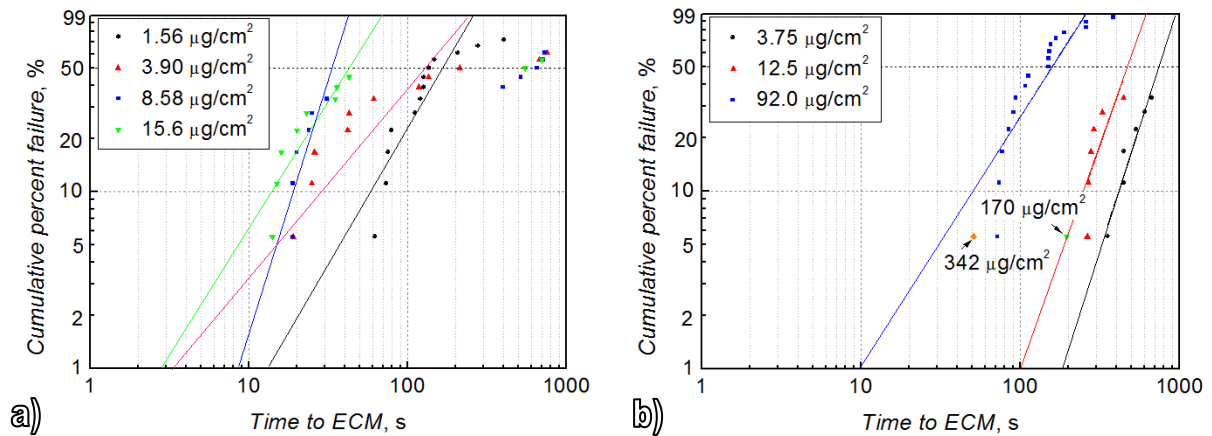
**Figure 4:** Cumulative failure dependence of time for (a) – NaCl and (b) – solder flux residue

As is seen from the graphs in **Figure 4**, increasing concentration shortens the time to an ECM event. This fact is also clear from the comparison of the time needed for 50 % of capacitors to show ECM as well as from the time to the first failure. In the case of NaCl, the increase of concentration from 1.56  $\mu\text{g}/\text{cm}^2$  to 15.6  $\mu\text{g}/\text{cm}^2$  reduces the time to first failure accordingly: 62s, 25s, 19s and 14s. The presence of flux residues reduces the time to the first ECM event from 354s to 72s with increase of concentration from 3.75  $\mu\text{g}/\text{cm}^2$  to 92  $\mu\text{g}/\text{cm}^2$ .

The results revealed contamination levels below which the probability of dendrite growth is very low. This empirically found limit for NaCl is in the range between 1.56  $\mu\text{g}/\text{cm}^2$  and 0.858  $\mu\text{g}/\text{cm}^2$ , whereas for “no-clean” solder flux residues investigated in this work, this limit is much more broad where it starts at 3.75  $\mu\text{g}/\text{cm}^2$  until it peaks around 92  $\mu\text{g}/\text{cm}^2$ . In general a decrease of TTF and to some extent an increase of cumulative percent failure was observed with increasing level of contamination (**Figure 4**). However a considerable reduction of ECM probability at very high

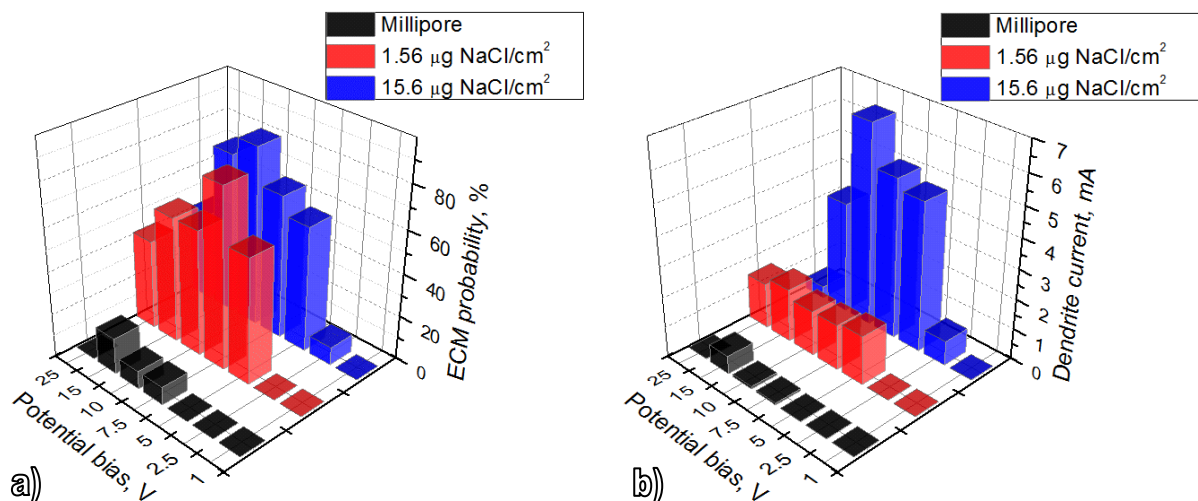
**Figure 7:** (a) – Comparison of the potential influence on ECM probability and (b) – dendrite current in terms of contamination

In general the probability of migration shows a bell curve with an increasing trend initially followed by a decreasing trend above the maximum, similar to the result found for increase in concentrations of contaminants. However, **Figure 7 (a)** shows

that the effect of contamination is more pronounced, especially from Millipore water to  $1.56 \mu\text{g}/\text{cm}^2$  chloride solutions. The dendrite current also shows a similar behavior except for a large increase of dendrite current at  $15.6 \mu\text{g}/\text{cm}^2$  conditions. This indicates the formation of thick dendrites, unlike in other cases. It shows that increased contamination increases the dissolution rate of the metal, which consequently forms thicker and more branched dendrites containing more metal and hydroxide precipitation. The high amount of metal content in the dendrites increases the current leaking through. However, as the potential increases, the probability of migration decreases, which also correlates with a decrease in the dendrite current. This is due to the fact that the rate of dissolution of tin increases with an increase in potential bias similar to increase in contamination. This leads to precipitation of the hydroxide species, while the heavy gas evolution at the anode and cathode also inhibit the formation of dendrites. Minzari et al. [11] have reported similar phenomenon with increase in potential bias or contamination level.

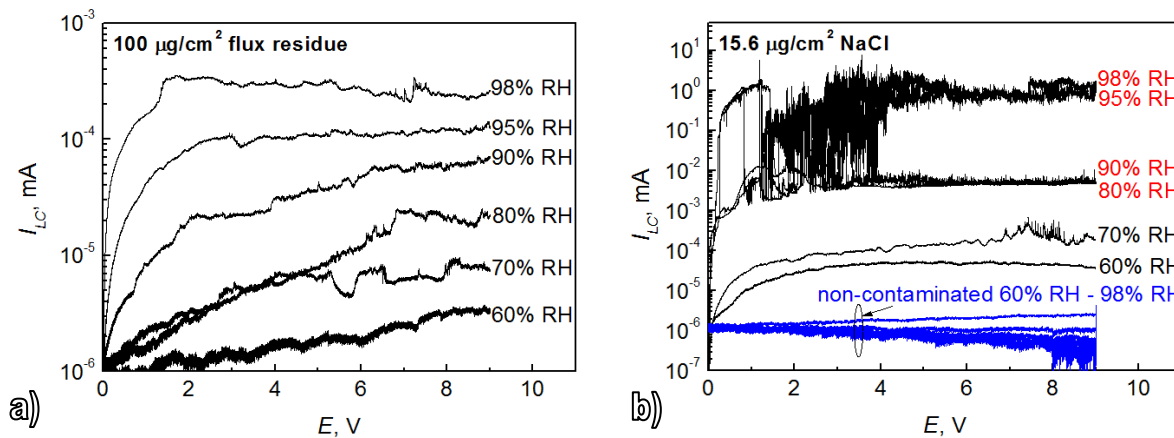
measured in the range from 0 V to 9 V with a sweep rate of 2 mV/s. The measured voltammetry curves as a function of RH are presented in **Figure 8**. The temperature during the experiment was kept constant at 25°C.

**Figure 8:** Leakage current as a function of applied potential and relative humidity: (a) – solder flux residue and (b) – NaCl and non-contaminated surface

The presence of flux residues (Cobar 390-RX-HT) is less effective in generating leakage current at all humidity levels compared to NaCl. With the increase of relative humidity from 60% to 98%, the leak current measured on the SIR comb pattern pre-contaminated with the flux residues has increased somewhat more than two orders of magnitude and no ECM initiation has been observed after the testing. Whereas in case on NaCl a more than four orders of magnitude increase in leak current has been observed when the relative humidity exceeded 80 % value. The observation of considerable increase of leak current is assumed to be an indication of NaCl dissolution and water layer formation on the SIR pattern. According to Kohler theory and Pöschl study on sodium chloride interaction with water vapour, the hygroscopic properties of NaCl enables adsorption of water molecules at RH around 75% [22]. The optical inspection of SIR comb pattern after the experiment revealed dendrite growth between the adjacent conductive lines. The increase of leakage current with increase of RH from 60% to 98%, measured on the non-contaminated SIR pattern was in scale of nA and negligible, indicating an importance of PCBA cleanliness for climatic reliability of electronics.

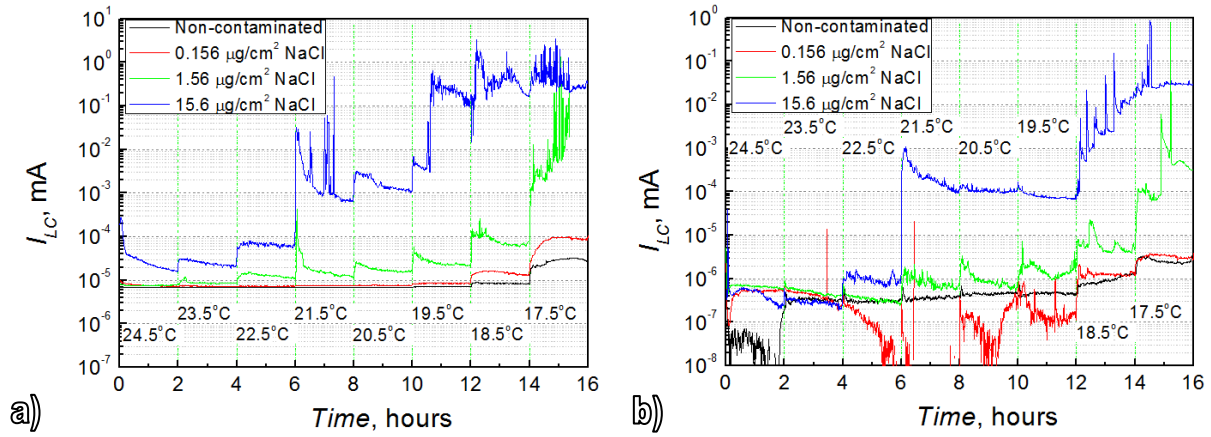
The effect of temperature difference between the PCB surface and surrounding air on the water condensation and leak current was studied on 10 surface mount ceramic chip capacitors connected in parallel and the SIR comb pattern biased at 5 V DC. The temperature of surrounding air has been kept constant at 25 °C. The leak current curves presented in **Figure 9** indicate the increase of current with increased difference in temperature of surrounding air and the surface of the PCB. The temperatures listed on the graphs are the average values of temperatures obtained with two RTD sensors places on the surface of the test PCB.

**Figure 9:** Leakage current measured on test PCB biased at 5 V DC (a) – SIR comb pattern and (b) – 10 ceramic chip capacitors size 0805 connected in parallel

For the non-contaminated condition, the increase of current is very little and it occurs during the last two steps, when the temperature difference between the surrounding air and PCB is sufficient enough for water condensation to occur. The increase of leakage current at  $0.156 \mu\text{g}/\text{cm}^2$  of NaCl occurs at the same steps as it was on a non-contaminated surface, but with slightly higher magnitude of current.

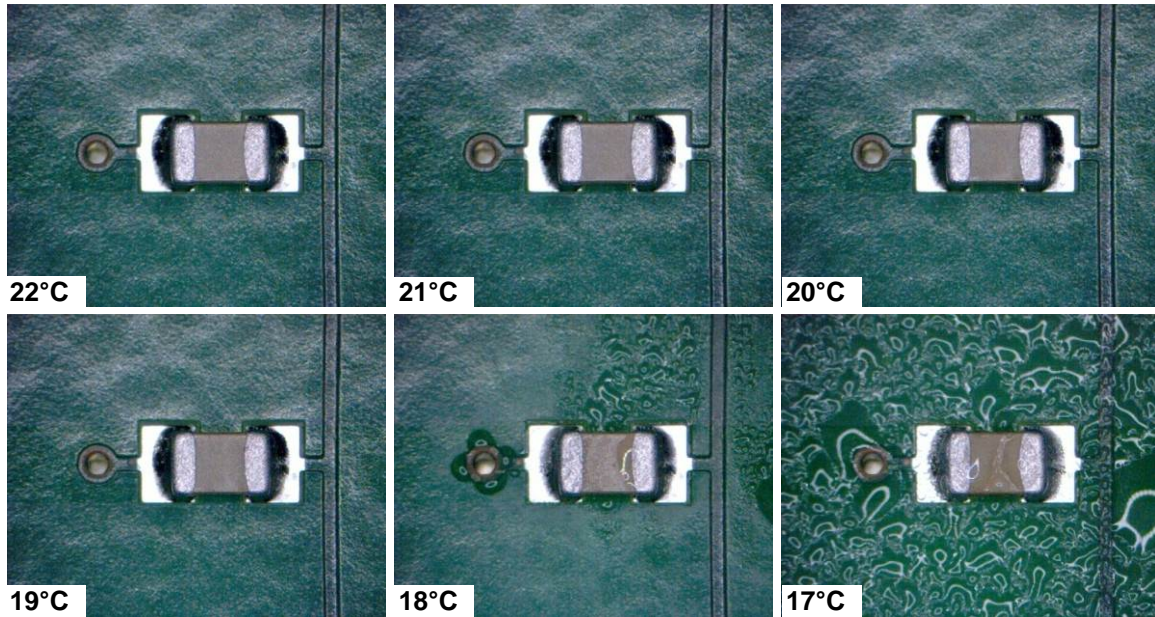
The effect of temperature difference on the condensation is presented in **Figure 10**. The expected error of temperature reading is 1°C. According to the leakage current measurements, the formation of thin water layer starts at 21.5°C, though it is not apparent from the captured images. A further decrease of temperature of the PCB increases the water build up on the surface, which is reflected in the leakage current versus time graphs. The condensation becomes clearly apparent when the temperature on the surface of PCB reaches 18°C.

**Figure 10:** Water condensation on size 0805 chip capacitors pre-contaminated with 15.6 µg/cm² of NaCl
